Research
Tunnel Engineering—Article

Lake Mead Intake No. 3

Jon Hurt ^{a,*}, Claudio Cimiotti ^b

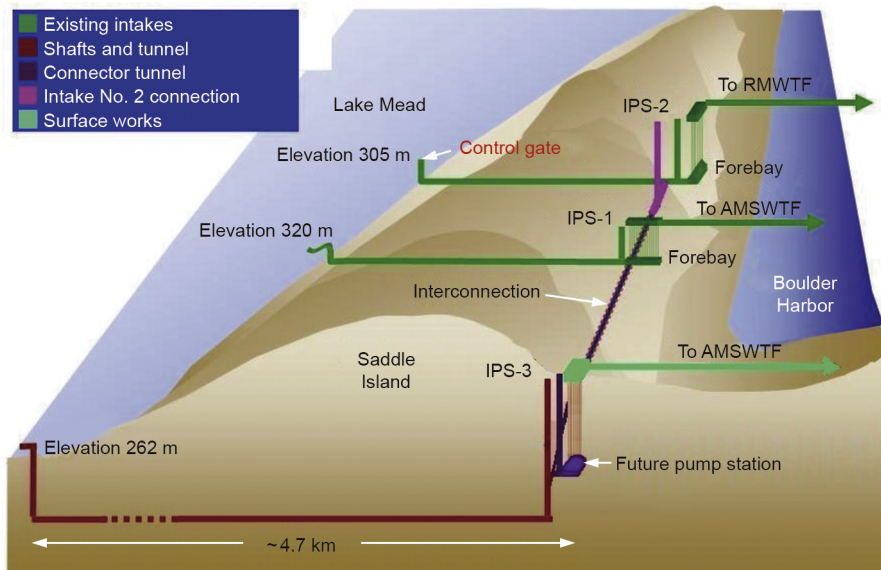
Fig. 2. Intake locations and connections to the SNWA water treatment facilities (RMWTF and AMSWTF). IPS: intake pump shaft.

The project location is shown in Fig. 1 and the final layouts of the three intakes are shown in Fig. 2. Fig. 3 shows the effects of the drought on the lake.

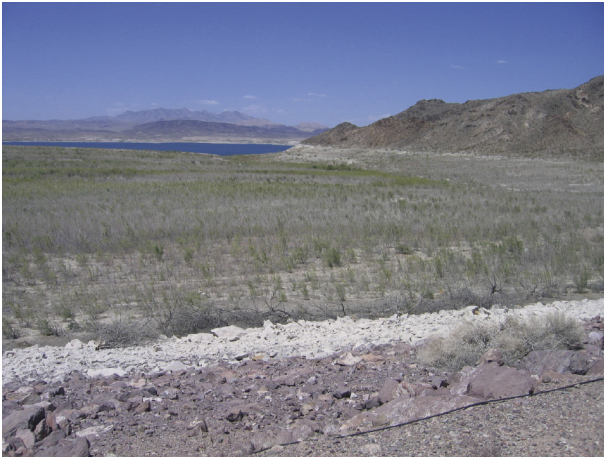
Fig. 3. View of Lake Mead; the area in the foreground was originally submerged, and the “bathtub ring” shows the original water level.

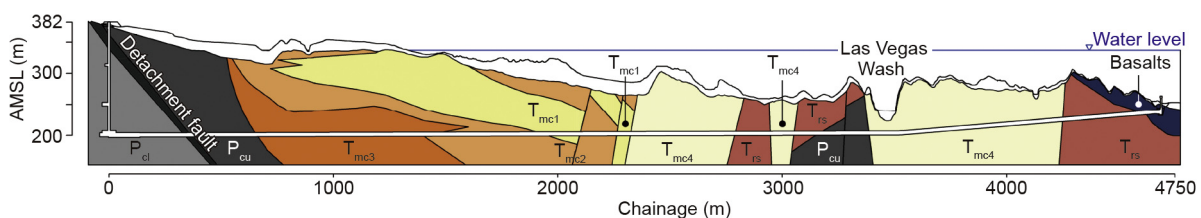
Fig. 4. Tunnel geology.

The ground along the alignment was characterized in terms of four major lithologic units—one Precambrian and three Tertiary units—with a number of subunits (Fig. 4). These units are as follows:

(1) **Saddle Island complex (P_c)**. The tunnel starts in stable Saddle Island lower plate (P_{cl}) metamorphic rocks with fair average rock-quality designation (RQD), and then passes through the detachment fault into stable Saddle Island upper plate (P_{cu}) metamorphic and volcanic rocks with poor average RQD. The detachment fault was 30–40 m thick at the tunnel horizon, and was short-term stable to unstable, with the potential for significant water inflows. It consisted of heterogeneous, crushed, and brecciated metamorphic and volcanic rocks with very poor to poor RQD. Rock strengths were up to 200 MPa in the Saddle Island complex.

(2) **Muddy creek formation (T_{mc})**. The majority of the tunnel was in the T_{mc} , a low-permeability sedimentary rock. Typical rock strengths in the muddy creek were 5–10 MPa and the rock mass permeability was low. The T_{mc} was subdivided into four units:

(3) **Red sandstone unit (T_{rs})**. Approaching the intake, the tunnel passed through the T_{rs} , an unstable conglomeratic breccia that is weak and unindurated to poorly indurated (soil-like).

(4) **Calville Mesa (basalt) unit (T_{cm})**. The intake structure and a short length at the end of the tunnel were in the T_{cm} , a stable and blocky to very blocky and seamy, vesicular, and non-vesicular Calville Mesa basalt.

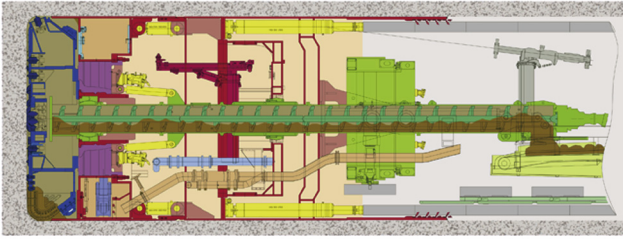
Fig. 5. TBM configuration (open-mode operation shown).

The TBM for the project (Fig. 5) was designed as a single-shield machine with capabilities to meet the range of challenges that were presented by the difficult hard rock ground conditions, potential for high groundwater inflows, and weak sedimentary rock under high hydrostatic pressures. It was anticipated that several sections of the tunnel, those with the more permeable rock, would require closed-faced excavation; that some lengths in the relatively impermeable sedimentary rock would be excavated in open mode; and that pre-excitation grouting would potentially be needed in some areas for excavation or maintenance stops. Therefore, VTC procured a fully shielded TBM that possessed the ability to operate in both pressurized and open modes and that could tunnel through rock, soil, and mixed-face conditions.

Particular attention was paid to probing and ground improvement ahead of the TBM, and the design allowed for 14 periphery and up to 30 face-drilling portals in order to provide a good range of hole locations. The machine was equipped with two drill rigs permanently located within the shield to allow drilling through the face, and a further permanent drill rig was situated behind the segment erection area to allow drilling through the periphery drilling ports in the TBM. Provision was also made for a fourth rig to be temporarily fixed on the segment erector. Drilling and probing were possible in all positions in open mode, and blow-out preventer units could be added to the majority of the holes to allow drilling in closed mode as well. Two grout plants were located on the back-up gantries, completed with silos, pumps, and mixers.

To deal with the risk of a sudden water inflow in open mode, a central horizontal screw conveyor was provided to remove muck from the face, rather than the more conventional conveyor found on rock machines. This allowed rapid closure of the gate within 120 s. In situations in which the rock face was unstable or groundwater inflows were excessive, a semi-closed or full-pressurized closed mode could be used with excavated spoil handling via a fully closed slurry circuit. Hyperbaric facilities were provided to allow access to the cutterhead chamber, with up to 17 bar of external water pressure.

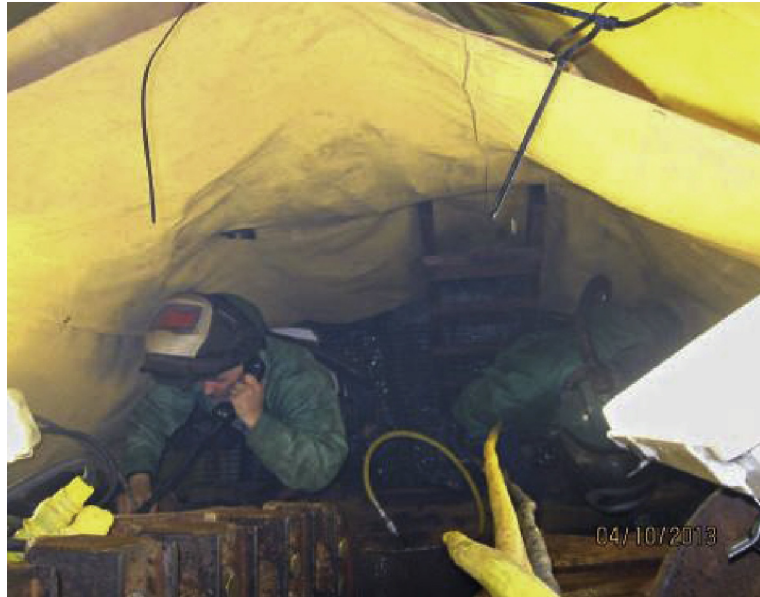
Fig. 6. Cutterhead repair.

When the slurry circuit maintenance was completed, the TBM advanced forward so that the unstable area was behind the TBM shield. However, after progressing 20 m, some steel fragments were found on the magnet at the slurry separation plant. It was decided to stop the TBM from advancing in order to investigate the problem. The pressure was successfully lowered to atmospheric level, and the face inspection showed that the central part of the cutterhead had severe damage to the cutters and the cutter housing. The water inflow was measured to be approximately $900 \text{ m}^3 \cdot \text{h}^{-1}$, but the rock condition was stable; therefore, maintenance work was started. A niche was excavated in front of the cutterhead using small hand tools. Once the excavation was completed, the structural repair to the cutterhead was performed. The water had to be panned away from the work area and ventilation had to be established for the cutterhead repair (Fig. 6). Technicians from the TBM manufacturer were brought to the site to oversee the repair. The central section of the TBM had to be repaired completely, including the disc cutter housings, structure, wear plates, and cutters.

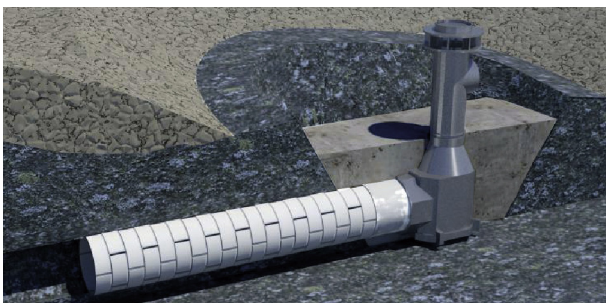
Fig. 7. A rendering of the intake structure.

Recognizing the risks, the VTC team looked at alternative configurations and construction methods. The chosen solution, shown in Fig. 7, was to utilize an intake structure that could be fabricated close to the shore and then be prepositioned into the lake bed using immersed tube techniques; this structure would serve as a location in which to “dock” the TBM at the end of the drive. Once the TBM entered the intake structure, and a seal was made between the TBM skin and the structure through grouting (or freezing if necessary), the TBM could be partially dismantled and a final concrete lining could be placed. For the bid, a steel structure

The intake structure had two main sections: the high-pressure section made from concrete, and the low-pressure section made from stainless steel. The high-pressure section was made of heavily reinforced 55 MPa concrete and was the base portion of the intake, forming the TBM reception chamber; this required the section to be designed to resist the external water pressure when the inside of the chamber was at atmospheric pressure.

The low-pressure section of the intake was the upper portion, which was made entirely of 316L stainless steel. It consisted of 16 m of total stainless riser, which was comprised of 14 m of 4.8 m diameter riser pipe topped by a trash rack approximately 2 m high. The riser pipe's design varied in thickness: The first 2 m attached to the corbel embed were made of 30 mm stainless plate, the next 5 m were made of 25 mm plate, and the remainder of the riser was made from 20 mm plate.

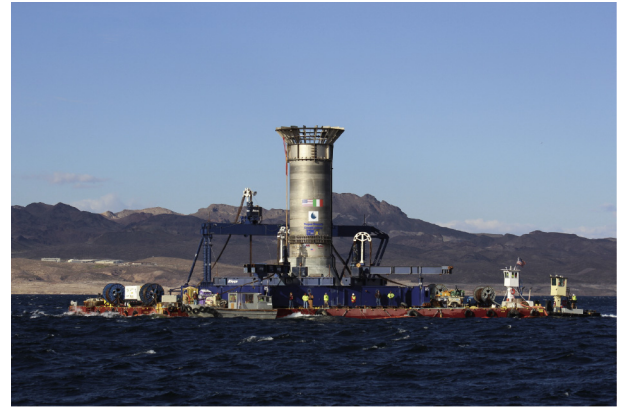
Fig. 8. Intake structure being lowered into position.

Once the frame was securely in position, the intake structure was towed out into the lake, as shown in Fig. 8. It was positioned above the frame and then successfully lowered by the strand jacks onto the frame using guide wires. Lowering took place over a period of approximately 60 h. Once the intake structure was completely placed on the bottom frame, another manual measurement of position and elevation was taken to confirm the position, and then all lifting and guiding cables were removed. The final position of the intake structure was verified to be within the tolerance of the design specs. The maximum deviation in northings and eastings was a difference of 380 mm in the easting of the TBM reception chamber. This final position was fed into the guidance system of the TBM and a small alignment correction was made to the TBM approach alignment.
