Research  
Tunnel Engineering—Article

# Upper Lillooet River Hydroelectric Project: The Challenges of Constructing a Power Tunnel for Run-of-River Hydro Projects in Mountainous British Columbia

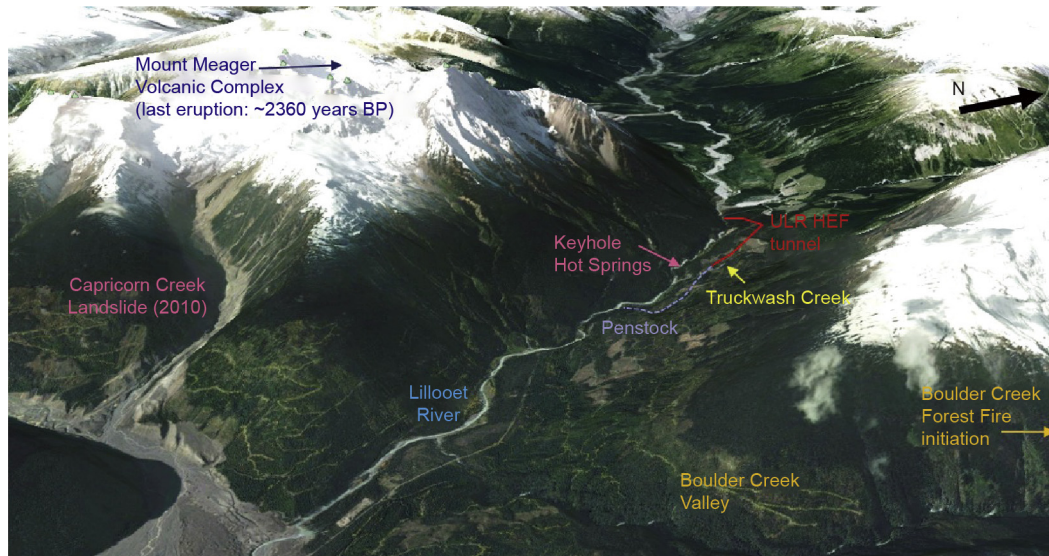
Fig. 2. Site layout within the Upper Lillooet River Valley [2].<sup>†</sup> BP: before the present.

The ULR HEF tunnel generally runs parallel to the northeast side of the ULR; access throughout the site is achieved along an existing forest service road (FSR). The ULR HEF tunnel was excavated as two headings, from the upstream portal at CH 0+065 to CH 0+582.5, and from the downstream portal at CH 2+533 to CH 0+582.5, at a grade of 0.4%. The tunnel intake and upstream portal are accessed from 49 km along the FSR, which is immediately across the ULR from the Mount Meager Volcanic Complex (Fig. 2) [2]. The downstream tunnel portal is accessed from 44.7 km along the FSR, and lies adjacent to an ecologically important waterway, Truckwash Creek. The powerhouse is accessed from 41.2 km, and sits on the north bank of the Lillooet River. Each of these individual work areas faced unique challenges, as discussed in Section 4.

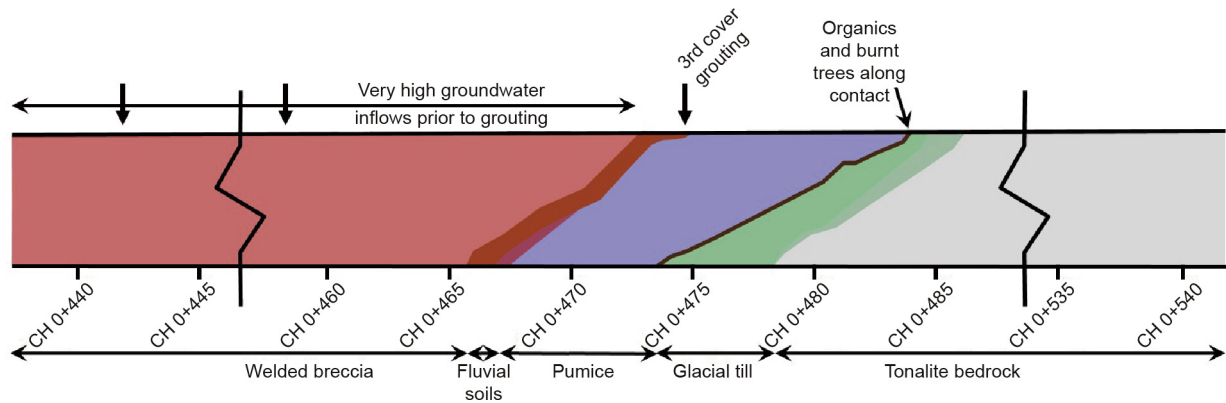
Fig. 3. Schematic tunnel profile through the transition zone soils, showing the deposits encountered along the tunnel excavation.

The ~2360 years BP eruption was preceded by an ejection of ash fall tephra (pumice) that left thick deposits throughout the valley, and deposited ash up to 1000 km away. The main eruption consisted of a hot block-and-ash flow with varying degrees of welding. The welded block-and-ash flow, labeled as a welded breccia, was the majority of the rock excavated in the upstream portion of the tunnel (CH 0+065 to CH 0+470). Between this fresh volcanic rock and the basement rock is an unconformity comprised of Quaternary soils and unconsolidated volcanic deposits. The unconformity was tunneled through between CH 0+466 and CH 0+478, and is referred to as “transition zone” soils in this paper, shown schematically in Fig. 3.

Within 7 m of first encountering the transition zone sediments, the welded breccia had risen above the crown of the tunnel, and the tunnel face was fully composed of grouted pumice. Excavation by roadheader proceeded well through the grouted pumice and underlying organics and till layers. After a further 5 m of excavation, within a full face of transition zone sediments, the tonalite bedrock was encountered rising up from the invert. Within 11 m of mixed soil and rock conditions, the tunnel was back to a full face of solid basement rock, and was excavated by short blast rounds (Fig. 3).

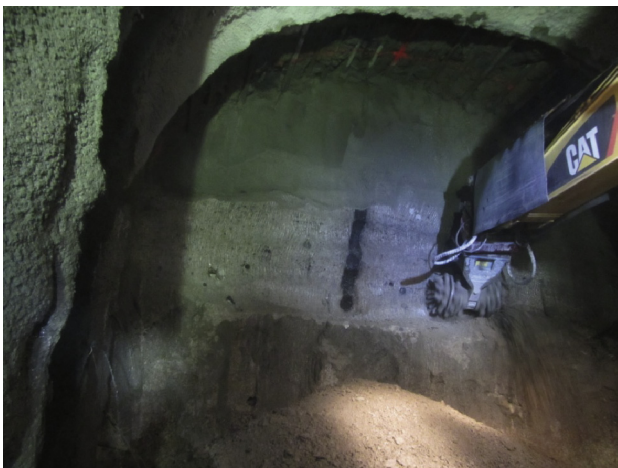
Fig. 4. Grouted pumice deposit containing a burnt tree.

- Most of the unconsolidated deposits that were encountered comprised pumice from the ~2360 years BP eruption. The pumice observed on the surface occurs in the form of loose gravel deposits at numerous locations throughout the valley, at volumes that support pumice mining. The 5 m thick layer of pumice encountered in the tunnel was mainly gravel-sized, contained burnt trees (Fig. 4), and included a lower layer that was reddish brown and organic rich.

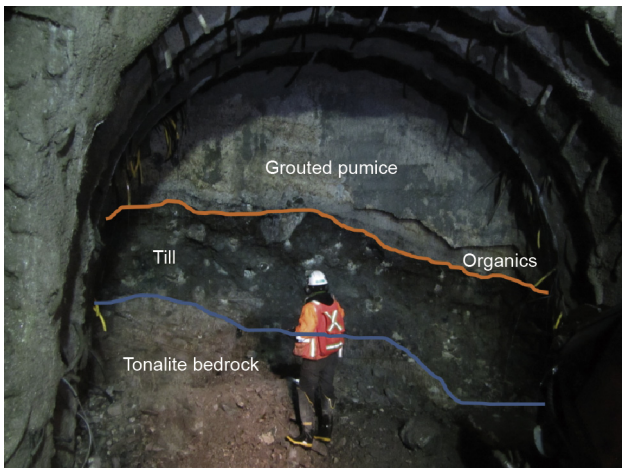
Fig. 5. Mixed face excavation with grouted pumice, organics, and till overlying tonalite bedrock.

Tonalite bedrock, which makes up the majority of the downstream tunnel excavation, was encountered below the till. Fig. 5 shows a mixed face with the majority of the layers observed during the excavation of the transition zone soils.

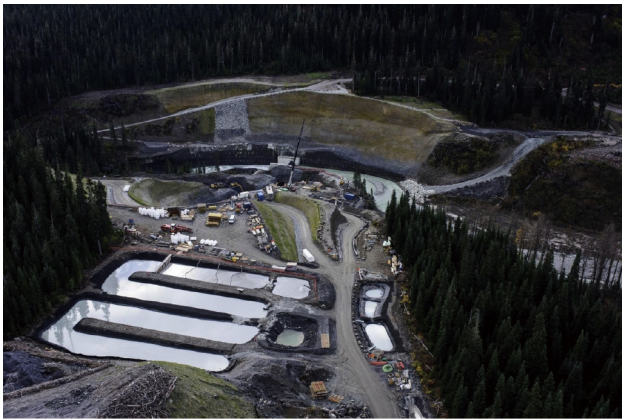
Fig. 6. ULR and construction water management facility at the upstream portal.

environmental regulations. Fig. 6 shows an aerial view of the settling ponds and water treatment at the upstream portal.

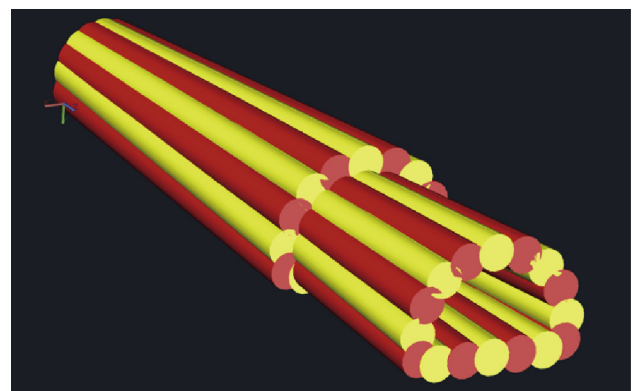
Fig. 7. Schematic of grouting program hole layouts illustrating overlapping grout covers [5].

the grout holes were up to 45 m long and there was greater than 20 m of overlap between nested rings of outwardly radiating, equally spaced grout holes (Fig. 7) [5]. Based on measured inflows and the results of water take (i.e., Lugeon) tests carried out prior to injection, the apparent viscosity of the grout mix injected was increased (i.e., thickened) and each stage was grouted to refusal, at the specified injection pressure and at a low to very low rate of injection. In this manner, adequate ground improvement to allow for stable mining conditions was achieved. The grouting program is discussed in detail in Ref. [5].
