Higher Performance Seismic Structures for Advanced Cities and Societies

Jiro Takagi^a, Akira Wada^b^a Graduate School of Urban Environmental Sciences, Tokyo Metropolitan University, Tokyo 192-0397, Japan^b Materials and Structures Laboratory, Tokyo Institute of Technology, Tokyo 226-8503, Japan

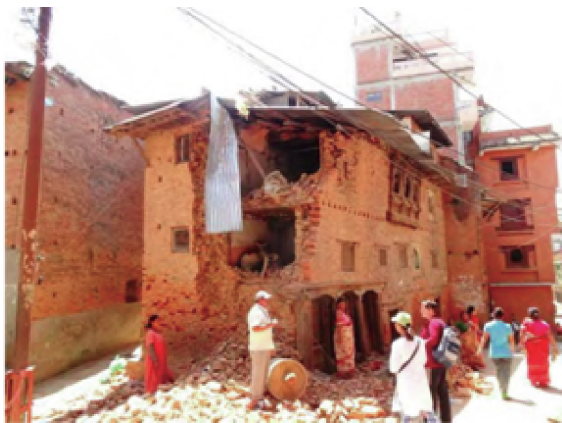
Fig. 1. Unreinforced masonry building damaged in the Gorkha earthquake in 2015 [3].

Structures are often constructed in a brittle manner due to a lack of knowledge or awareness of earthquake risk, and/or due to budget constraints. Fig. 1 shows an unreinforced masonry building that failed in the Gorkha earthquake in Nepal in 2015. Bricks became detached in unusual directions under strong shaking during this major earthquake, causing the building to fall apart. Similar damage has been observed in many other earthquakes including those in L'Aquila (Fig. 2), Haiti, Sichuan, Amatrice (Fig. 3), and Puebla. Masonry structures have been widely adopted in many regions in order to take advantage of their ease of construction, which allows bricks to be laid without the use of large construction machines. However, the strength of the connections between the bricks is typically insufficient to resist strong shaking during major earthquakes. Possible countermeasures include installing wooden frames or reinforcement (Fig. 4) and strengthening the mortar cement. Many of these buildings are non-engineered and have been constructed without the proper involvement of structural engineers. Although the seismic strength of such masonry buildings varies widely, and its assessment is difficult, greater involvement of structural engineers is needed.

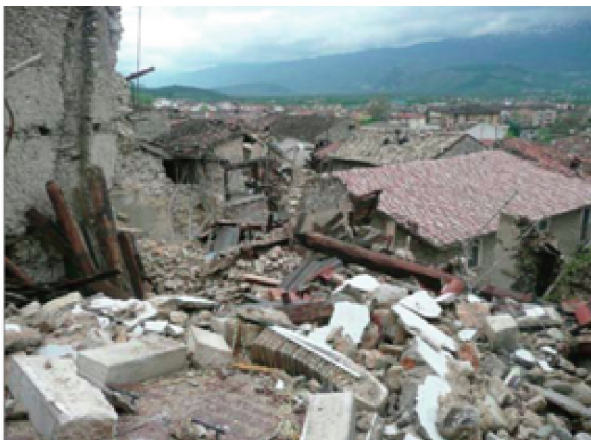
Fig. 2. Collapsed masonry buildings in the L'Aquila earthquake in 2009 [4].

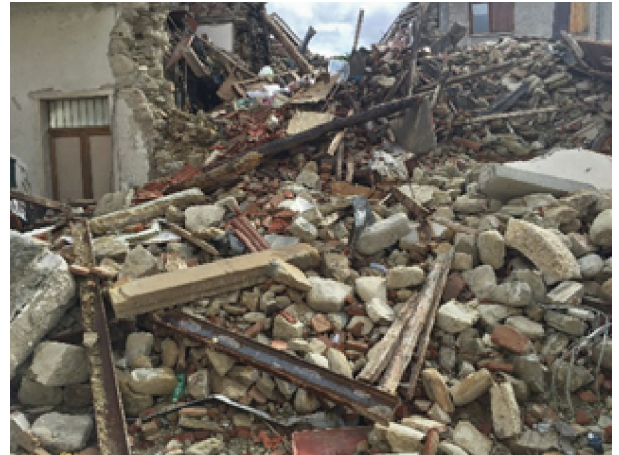
Fig. 3. Collapsed masonry buildings in the Amatrice earthquake in 2016.

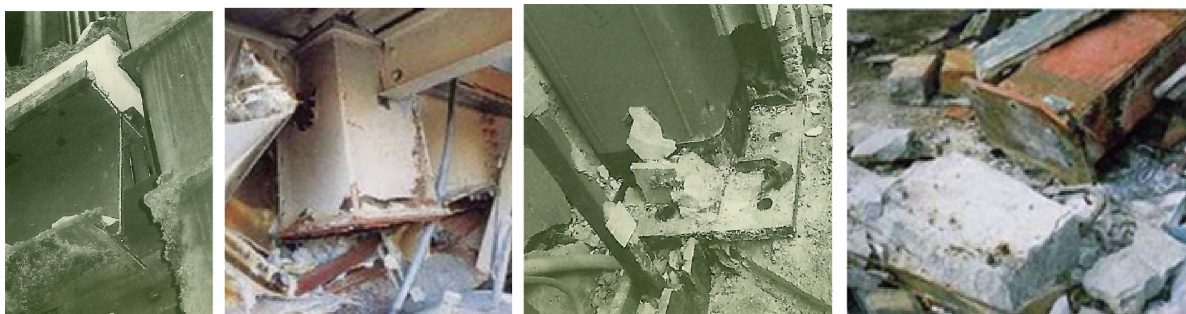
Fig. 7. Failure of steel structures in the Great Hanshin earthquake [7].

Steel is a type of ductile construction material and steel structures can be ductile; however, inadequate detailing or construction may cause such structures to experience brittle failure under large earthquakes. Fig. 7 shows brittle failure in steel structures that occurred in the Great Hanshin earthquake. The welding at beam-to-column connections had failed and anchor bolts had ruptured. Connection detail requirements were revised after this earthquake.

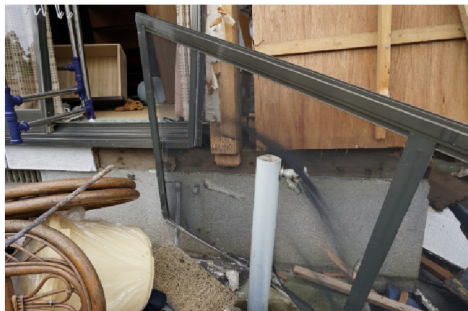
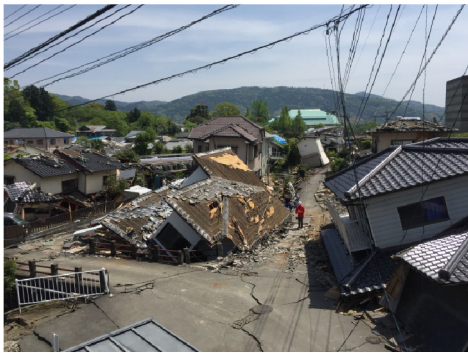
Fig. 9. Wooden houses in the Kumamoto earthquake in 2016. (a) Connection failure; (b) collapsed houses.

Most houses in Japan are wooden, and many of these old wooden houses are non-engineered. Fig. 8 shows a failure of connections between columns and beams. The collapse of wooden houses caused more than 90% of the casualties in the Great Hanshin earthquake. More than 20 years later, the Kumamoto earthquake occurred in 2016. Fig. 9(a) shows a failure between a wooden column and the sill. As Figs. 8 and 9(a) show, certain aspects have not been improved over the last 20 years in the field of structural engineering. Connection failures still lead to the collapse of houses (Fig. 9(b)).

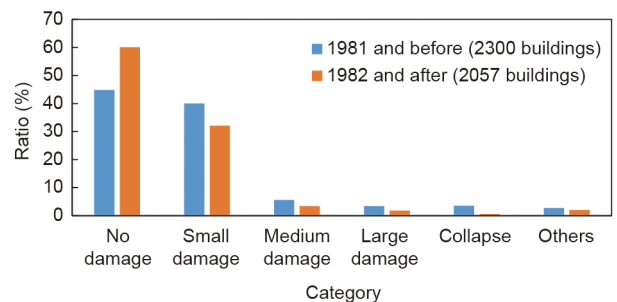
Fig. 10. Percentages of damaged buildings in the Great Hanshin earthquake [6].

The application of this seismic design philosophy significantly improves the safety of residents in structures. In fact, the number of severely damaged or collapsed buildings in large earthquakes in Japan decreased dramatically for buildings designed after enforcement of the revised seismic design regulations. Fig. 10 shows the percentages of damaged RC buildings, as investigated near the epicenter of the Great Hanshin earthquake [6]. It is notable that the total percentage of buildings constructed after the 1981 revision that experienced medium to large damage or collapse was 5.8%, whereas the total percentage for buildings constructed before the revision was more than double, at 12.5%.

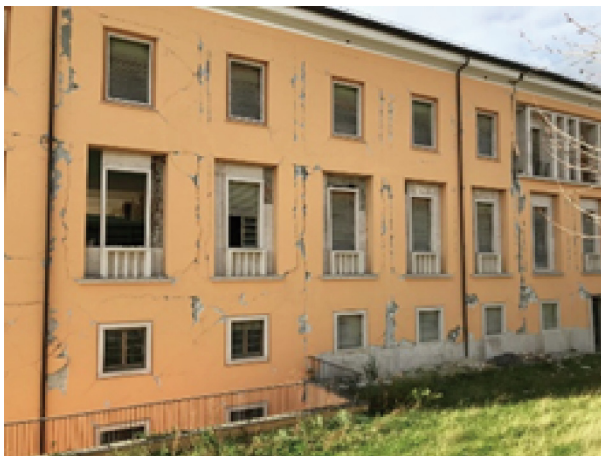
Fig. 12. A damaged building that did not collapse but remained unused after the Amatrice earthquake of 2016.

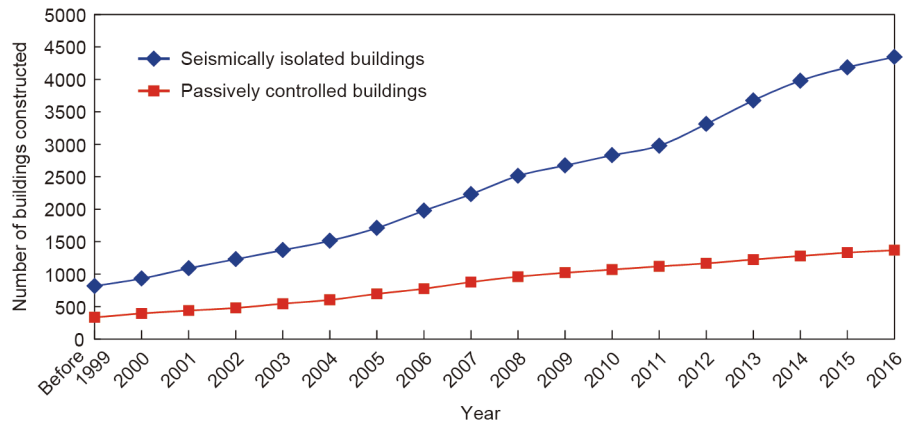
Fig. 16. Statistics of seismically isolated and passively controlled buildings in Japan.

Fig. 16 shows the cumulative number of seismically isolated and passively controlled buildings constructed in Japan after 1999. Seismically isolated structures have been used to a greater

degree for major buildings such as hospitals, large warehouses, and high-rise residential buildings. The number of seismically isolated structures constructed until 2016 is more than 4000. Passively controlled systems have been installed in many high-rise buildings, and in most of the recent ones. This trend shows that people are increasingly recognizing the performance and effectiveness of these buildings against earthquakes: Fewer buildings were damaged in recent major earthquakes in one of the most earthquake-prone countries in the world.

The data in Fig. 16 include only large-scale buildings; therefore, the real number of seismically isolated and passively controlled buildings must be much greater. This is especially true for passively controlled buildings, which can now be designed within a regular building approval procedure without peer reviews by specialists, if the buildings are not very large. As an example, Fig. 17 shows an interior view of a six-story university building in which BRBs are used and exposed in the community space. There are many relatively small seismically isolated and passively controlled buildings in Japan; these are not included in the statistics in Fig. 16.

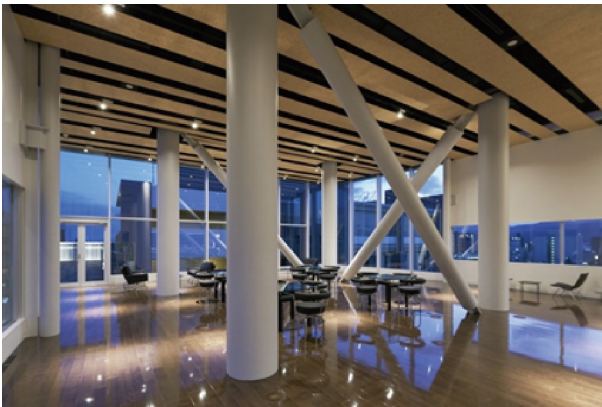
Fig. 17. A passively controlled building using BRBs (the Kyoto University of Foreign Studies).
