Research  
High Performance Structures: Building Structures and Materials—Article

## Testing of a Full-Scale Composite Floor Plate

Dennis Lam <sup>\*</sup>, Xianghe Dai, Therese Sheehan

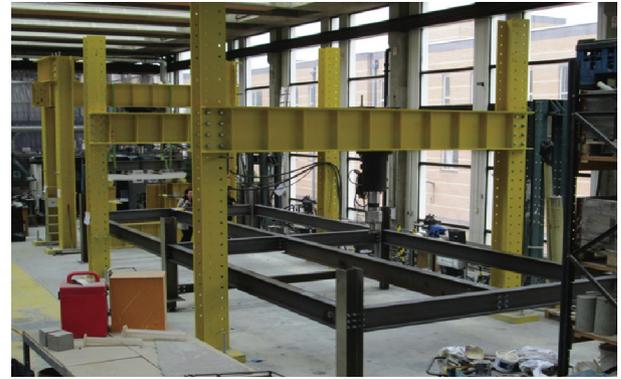
Fig. 2. Layout of the beams and columns in the floor plate test.

The floor beam and column arrangement is shown in Fig. 2. The columns were 1.0 m high and the two central columns were designed to be 200 mm shorter than the other four corner columns, so that load cells could be placed underneath them to monitor the loads transferred to the central columns. The two central columns were tied to prevent outward movement, since it is possible that a small moment might be generated in the columns through the connections. An endplate with the dimensions 180 mm × 220 mm × 10 mm was welded to the web of the internal secondary beams (IPE300, sections were notched to fit) and bolted to the web of the primary beams (IPE270) using six No. M20 Grade 8.8 bolts (the bolt spacing was 70 mm in the vertical direction and 100 mm in the horizontal direction). An endplate with the

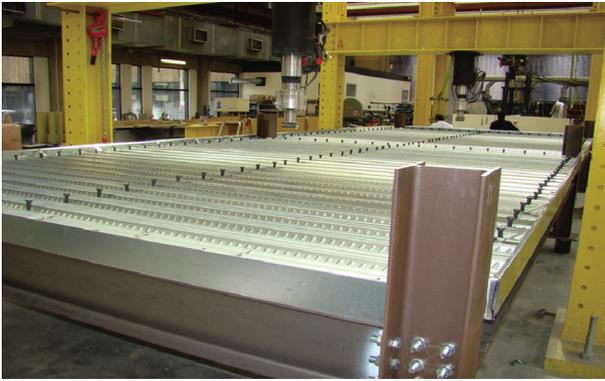
Fig. 4. Steel decking and shear connector arrangement.

The composite slabs consisted of a 130 mm thick slab with a 0.9 mm thick, 58 mm deep profiled decking (Cofraplus 60 from ArcelorMittal S.A.). The deck profile had ribs spaced at 207 mm and allowed the welding of a stud in the middle of the rib. Single 19 mm diameter shear studs (100 mm nominal height) were used, and the spacing of the studs was chosen to be 200 mm for the primary internal beams and 207 mm for all the secondary beams. Since the profiled decking was discontinued at the primary beam, the shear connectors were welded directly to the primary beams while through deck welding was used for the secondary beams. The shear connector details are shown in Figs. 4 and 5.

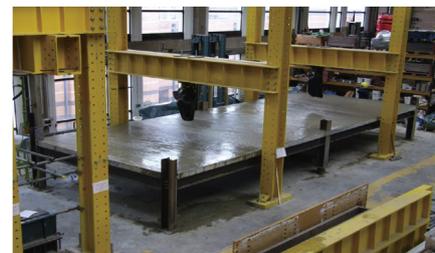
Fig. 6. Composite floor plate specimen before and after concrete casting. (a) Reinforcement mesh for the specimen; (b) the dimension of the U-bars arranged at the edge (unit: mm); (c) composite floor plate after casting.

The reinforcement adopted for the specimen was A142 mesh, as shown in Fig. 6, which was equivalent to the 0.2% minimum reinforcement in the concrete topping according to Eurocode 4. It was

positioned 40 mm from the top of the slab, as shown in Fig. 5, so that it was just below the head of the shear connectors. The decking was discontinuous at the internal primary beam but continuous elsewhere. This was done so that the decking did not act as effective transverse reinforcement. To compare the effects of having no U-bar, 10 mm U-bars were placed around the shear connectors only on one edge of the floor plate. Figs. 6(a) and (b) show the reinforcement mesh in place and the details of the U-bars. The floor plate was cast unpropped. Fig. 6(c) shows the whole composite floor plate after casting.

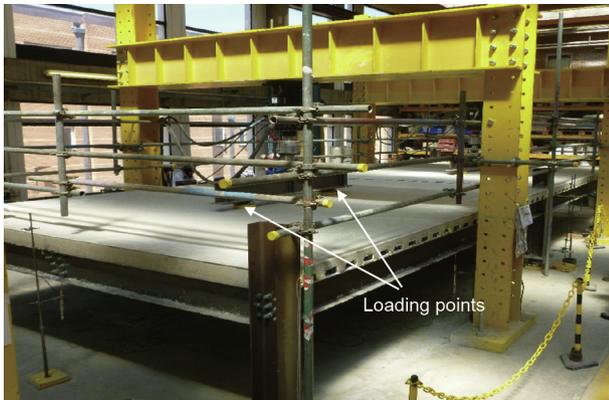
Fig. 11. Loads applied to the internal secondary beam.

The loading of the primary beam occurred through the point loads on the internal secondary beams, as shown in Fig. 11. The load positions on the secondary beams were placed 1.4 m apart

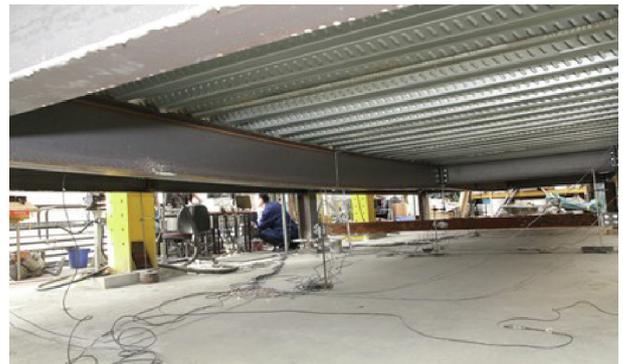
Fig. 12. Deflection of internal secondary beams at maximum load.

Table 1 summarizes the maximum deflections and slips that correspond to the maximum load for each loading cycle and the residual deformation after unloading. Up to the test load of 20 kN·m<sup>-2</sup>, the maximum vertical deflection at the mid-span of the edge secondary beam (LVDT 8) was 2.17 mm; this was about 18% of the maximum vertical deflection at the mid-span of the internal secondary beam (LVDT 2), which was 11.90 mm. The maximum deflections at the mid-span of the central and edge primary beams (LVDT 3 and LVDT 1) were 5.03 and 2.45 mm, respectively. All residual deflections after unloading were very small—less than 2 mm. At the failure load of 46 kN·m<sup>-2</sup>, which corresponded to the total equivalent uniform failure load of 49 kN·m<sup>-2</sup> including the self-weight of the slab (3 kN·m<sup>-2</sup>), the maximum deflection at the internal secondary beam (LVDT 2) was 68.30 mm. The maximum deflections for the central and edge primary beams (LVDT 3 and LVDT 1) were 22.30 and 7.14 mm, respectively. The average value of the deflection of the primary beams was 14.7 mm at the failure load, so the net deflection of the internal secondary beam at the failure load was equal to 54 mm (span/96). Fig. 12 shows the deformed shape of the secondary beams.

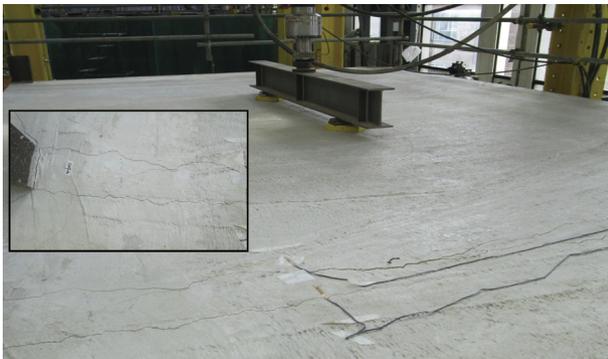
Fig. 15. Cracks at the top surface of the slab along the central primary beam.

The crack width along the central primary beam was measured manually using a crack microscope and was recorded in loading cycle 5: A crack width of 0.5–0.8 mm developed at  $10 \text{ kN}\cdot\text{m}^{-2}$ , and 1.2–1.6 mm wide cracks occurred at  $20 \text{ kN}\cdot\text{m}^{-2}$ . The crack widths increased to 1.5–2.0 mm at  $30 \text{ kN}\cdot\text{m}^{-2}$  and to 1.7–3.7 mm at  $40 \text{ kN}\cdot\text{m}^{-2}$ . At the failure load of  $46 \text{ kN}\cdot\text{m}^{-2}$ , the crack widths were 2.7–4.7 mm.

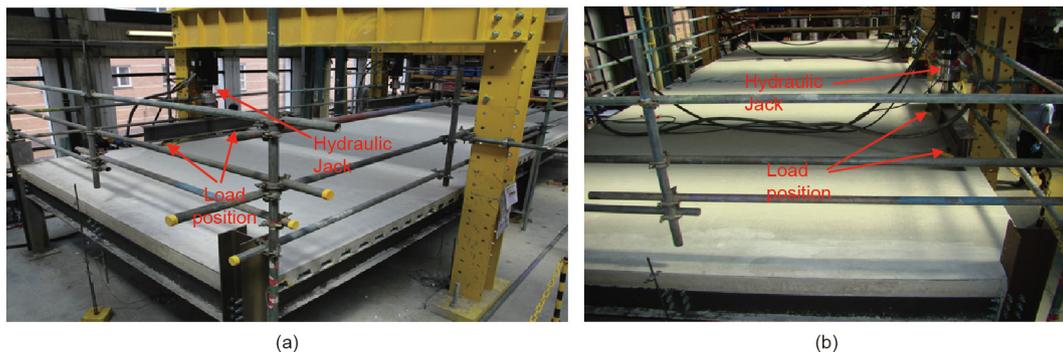
Fig. 16. Edge beam tests (a) with and (b) without U-bars.

The loading on each of the edge secondary beams was applied directly to the beam by two point loads, as shown in Fig. 16. To calculate the loaded area acting on the edge beam, the loaded width of the slab was calculated based on half of the spacing between the center line of the secondary beams ( $=1.89 \text{ m}/2$ ) plus the slab edge distance of 0.1 m. The load applied by the actuator was converted to an equivalent uniform loading by dividing the load by  $5.5 \text{ m}^2$  (given the loaded area of  $5.24 \text{ m} \times 1.05 \text{ m} = 5.5 \text{ m}^2$ ). In total, three loading cycles were performed on each edge beam. The first two cycles of loading were applied up to  $40 \text{ kN}\cdot\text{m}^{-2}$ . The load in the third cycle was then increased to the eventual failure load of  $60 \text{ kN}\cdot\text{m}^{-2}$ . Typical deflections and strains of the beams and column were recorded. The displacement transducer and typical strain gauge positions are shown in Figs. 9 and 10. Table 3 summarizes the maximum deflections and slips at the maximum load of each cycle and the residual deformation after unloading. Tables 4 and 5 summarize the typical maximum strains that occurred at the maximum load of each cycle and the residual strains after unloading. Fig. 17 presents typical load–deflection relationships at typical monitoring positions. Fig. 18 shows typical strain observations.

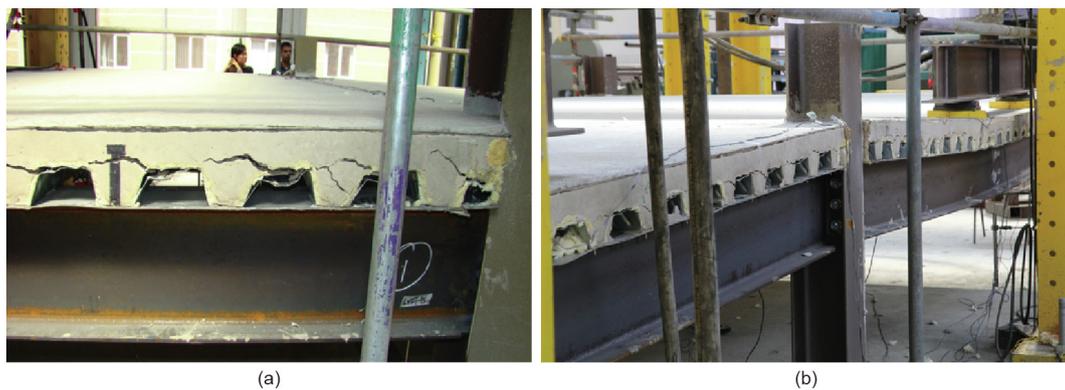
Fig. 19. (a) Crack at the edge of the slab without U-bars at failure, and (b) deflection of the edge beam with U-bars.

Fig. 19 clearly shows the cracking pattern due to the longitudinal shear failure for the edge beam without U-bars and the edge beam with U-bars at failure. For the secondary edge beam with
