Defects and Countermeasures of Highway Subgrade in Plateau Permafrost Regions

State Key Laboratory of Road Engineering Safety and Health in Cold and High-Altitude Regions, CCCC First Highway Consultants Co., Ltd., Xi'an 710075, China

Abstract: This study collects the maintenance history, reconstruction material, and disease data of the Qinghai–Tibet Highway (QTH) over the past 60 years. The QTH is then divided into a stable region, a basically stable region, an unstable region, and an extremely unstable region based on road deterioration rate. Subsequently, 134 km of typical deteriorated sections are selected, and the relations between the road deterioration and the mean annual ground temperature (MAGT), permafrost degradation rate, and ice content are studied based on the survey data. The average road service life is determined in addition. Newly developed diseases and their temporal effects are analyzed using treatment measures. Furthermore, new stabilizing technologies adapted to large-scale permafrost subgrade (e.g., distributed ventilation subgrade, unidirectional heat conduction board subgrade, and integrated pavement-subgrade heat drainage structure) are introduced. The re

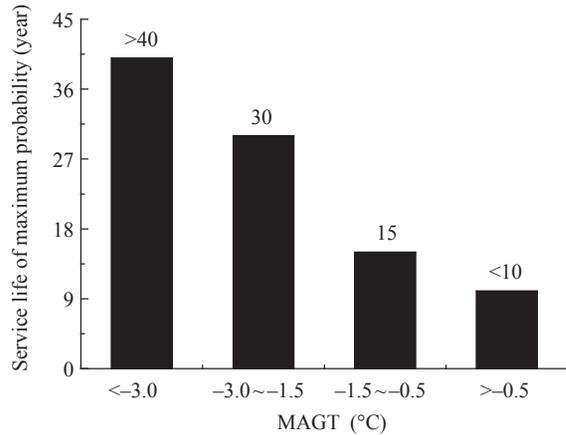
Fig. 1. Relationship between MAGT and service life of maximum probability.

From Fig. 1, Table 1, and Table 2, we see that the subgrade service life of maximum probability continuously decreased with increasing MAGT. In the stable region, where the MAGT was lower than $-3.0\text{ }^{\circ}\text{C}$, the service life of 80% of the road sections exceeded 40 years. When the MAGT was between $-3.0\text{ }^{\circ}\text{C}$ and $-1.5\text{ }^{\circ}\text{C}$, the ratio of road sections with the same service life declined to 35%; the service life of most surveyed road sections was shortened by more than 10 years. When the MAGT was from $-1.5\text{ }^{\circ}\text{C}$ to $-0.5\text{ }^{\circ}\text{C}$, 65% of the subgrade was damaged within 15 years, and the remaining 35% subgrade was not in service for more than 10 years. When the MAGT was from $-0.5\text{ }^{\circ}\text{C}$ to $0\text{ }^{\circ}\text{C}$, the 80% subgrade service life was less than 10 years. The average service life proposed in Fig. 2 can be calculated from following equation:

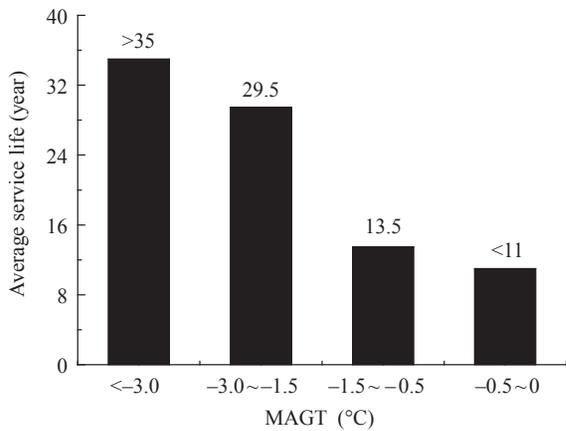
Fig. 2. Relationship between MAGT and average service life.

15 years, 20 years, 30 years, and >40 years), T_i is the time limit of each road segment, and ρ is the ratio of the subgrade length to the total survey length for each time period. According to the calculation, the road average service life was reduced by more than 4 years with a 0.5 °C increase in MAGT. From the analysis of reduced service life, the subgrade temporal effect was the most significant when MAGT changes near -1.5 °C.

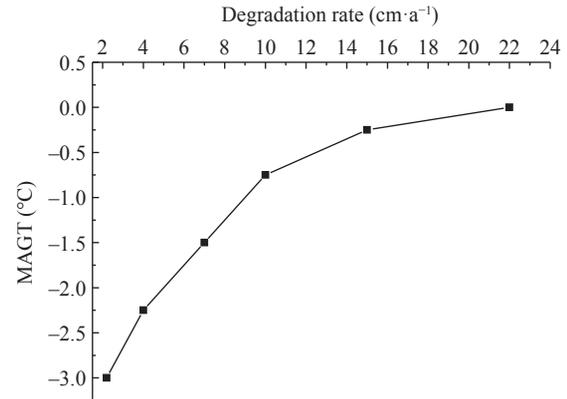
Fig. 3. Relationship between MAGT and degradation rate.

Fig. 3 shows that MAGT was positively correlated with permafrost table degeneration rate. The permafrost table degradation rate was less than 10 $\text{cm}\cdot\text{a}^{-1}$ when MAGT was below

-3 °C (Table 1). The permafrost table degradation rate gradually increased with increasing MAGT; however, the degradation accelerated. The degradation rate only increased by approximately 1.67 $\text{cm}\cdot\text{a}^{-1}$ for a 0.5-°C increase in MAGT within the range of -3 °C to -1.5 °C. Within the range of -1.5 °C to 0 °C, the degradation rate rapidly increased, rising to 5 $\text{cm}\cdot\text{a}^{-1}$ when the ground temperature rose by 0.5 °C. The relationship between MAGT and permafrost table degradation rate showed that a -1.5 °C MAGT was a turning point for the conversion of warm and cold permafrost. When the MAGT of the permafrost was higher than this value, the permafrost table degradation rate accelerated.

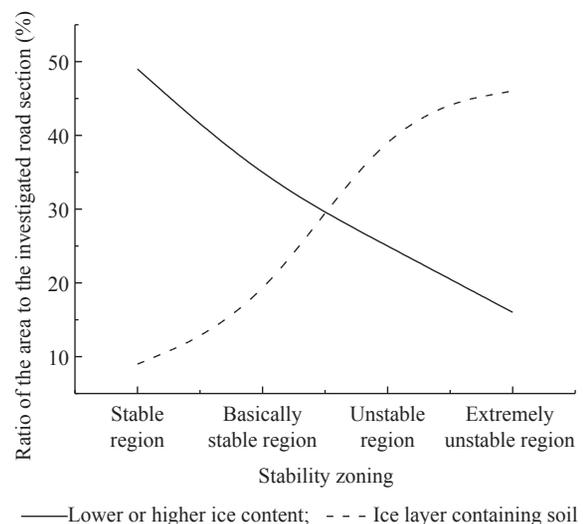
Fig. 4. Relationship between ice content and stability class.

In stable regions, the proportion of road sections with an ice layer containing soil was only 9%. However, this proportion rose to 46% in extremely unstable regions, as shown in Fig. 4. The average road service life got shorter with an increased ratio of high-ice-content sections. Specifically, in warm and rapidly-degrading permafrost regions, the ice layer subgrade containing

soil typically caused defects within 2 to 3 years after paving the asphalt. Additionally, these regions needed urgent remediation due to serious defects after 5 to 10 years of operation.

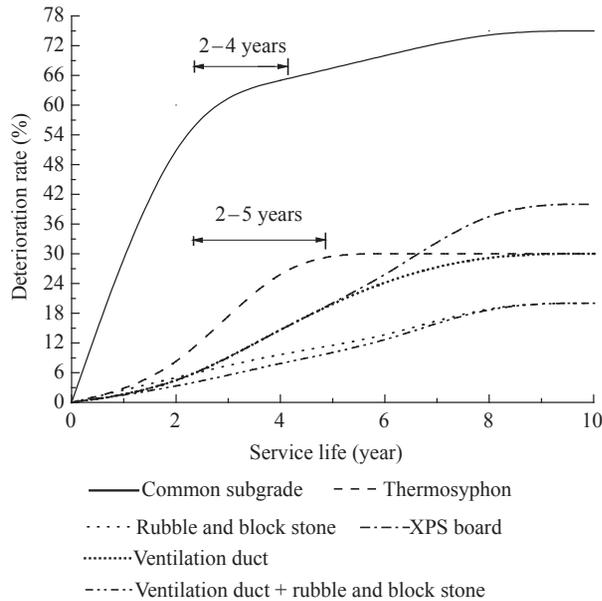
Fig. 5. Service life of different special treatments.

Fig. 5 shows that if no special measure was taken on a road section with poor geological conditions, approximately 80% of road sections would have serious subgrade damage within 2 to 4 years, and that the subgrade would remain unstable after reconstruction. In treatments using thermosyphon, XPS board, rubble and block stone, and ventilation duct subgrades, the effective prevention rate of road defects was between 60% and 80%. Most of the defect cases would be identified within 2 to 5 years after subgrade construction, and defect incidence would gradually stabilize. Our results show that special treatment measures

must be remedied twice, and that the working status of the subgrade gradually stabilized after reconstruction.

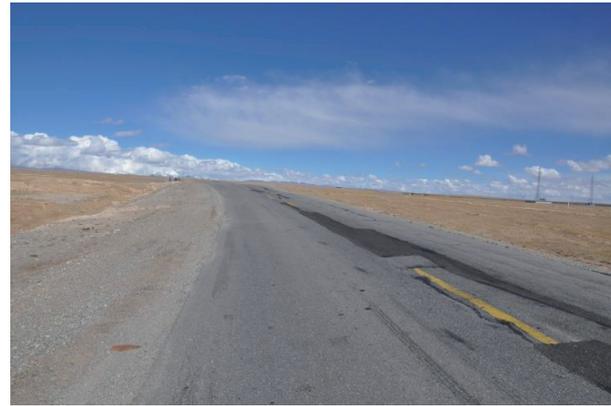
Fig. 6. Potholes above thermal insulation board subgrade.

In the surveyed XPS insulation board subgrade sample, 90% of the insulation board subgrade prevented heat absorption from the asphalt pavement. However, only 60% of all treatment measures played a role in preventing defects from occurring. At the beginning of construction of the thermal insulation subgrade, the road defect incidence was relatively small, at only 3% to 15%. The road defect incidence rapidly increased after the fourth year. The road defect incidence reached 40% in the eighth year; the main forms of defects were settlement and pothole formation. As a passive heat-resistance measure, the insulation board delays the defect occurrence where the subgrade defects is caused by permafrost thawing. However, defects could not be completely eliminated (Fig. 6).

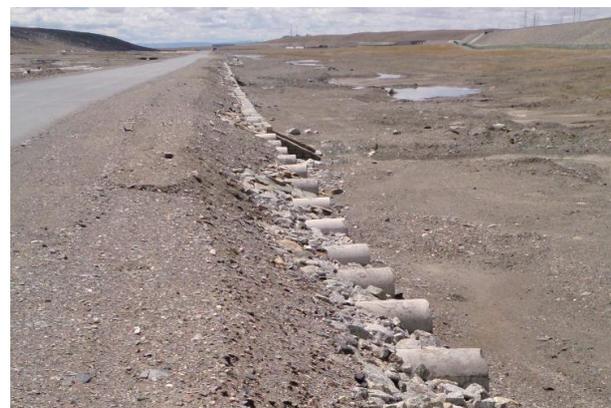
Fig. 7. Used case of ventilation-duct subgrade.

In the surveyed ventilation-duct subgrade sample, 90% of the ventilation-duct subgrade could reduce the subgrade temperature by introducing ambient “cold energy”. Specifically, for several test sections, a temperature-controlled switch was used. The ventilation duct damper could be closed in warm seasons and opened in cold seasons, which greatly improved the cooling efficiency. 70% of the ventilation-duct subgrade effectively prevented road defects. Additionally, when ventilation ducts and rubble and block stone were used in combination, the defect treatment efficiency could be increased to 80%. Note that some of the ventilation ducts might be blocked, which affects the cooling effect of the structure due to pavement settlement and the accumulation of wind sand. The ventilation-duct subgrade is shown in Fig. 7.

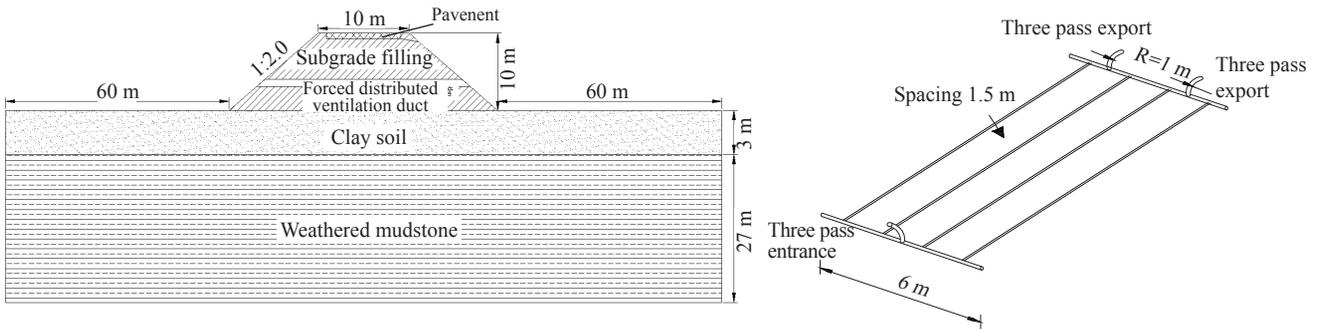
Fig. 8. Schematic diagram of forced distributed ventilation-duct subgrade.

The forced distributed ventilation subgrade was controlled by an intelligent control module. In cold seasons, the fan is started by the intelligent control module and cold air flows along the distributed ventilation based on forced wind. In warm seasons, the fan is closed and the thermal resistance of the subgrade increases, which avoids downward heat transfer and is favorable to protecting the underlying permafrost. A schematic diagram of the forced distributed ventilation subgrade is shown in Fig. 8.

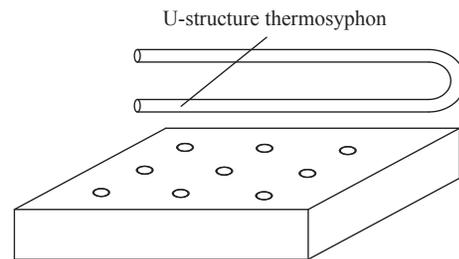
Fig. 9. Design scheme of unidirectional heat conduction board.

The unidirectional heat conduction board subgrade was composed of a thermal insulation board and a small thermosyphon. On the one hand, in warm seasons, the heat absorbed by the black asphalt pavement was resisted by the thermal insulation board based on its higher thermal insulation performance. On the other hand, in cold seasons, cold air was introduced into the subgrade, the temperature of the subgrade decreased, and the permafrost table did not degrade. The design scheme and prin-

principle of the unidirectional heat conduction board are shown in Fig. 9 and Fig. 10, respectively.

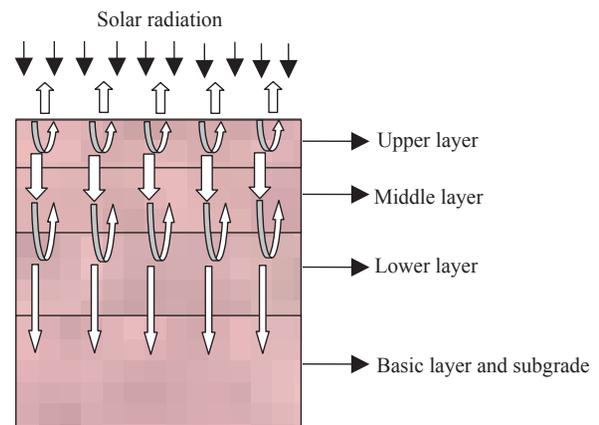
Fig. 10. Principle of operation of unidirectional heat conduction board.

Heat transfer in the pavement was regulated by establishing a gradient heat conduction structure. The design principle is shown in Fig. 10. First, the thermal conductivity of the upper layer was changed to reduce heat being absorbed from solar radiation as much as possible. Second, the structure had high thermal conductivity in the middle layer and low thermal conductivity in the lower layer, which was detrimental for heat transfer from the middle layer to the lower layer. Therefore, the integrated pavement-subgrade heat drainage structure could reduce heat accumulation in structure layers.
